# APPENDIX C: GROUND PENETRATING RADAR SURVEY REPORT

## Purpose and Overview

A series of ground penetrating radar surveys were conducted on two fields permitted to receive slurry applications (Fields 1 and 12) and one planned for possible future applications (Field 5a), to investigate subsurface soil properties. Participating were Wes Tuttle, Geophysical Soil Scientist, NRCS; Richard Vaught, Soils Scientist and GPR operator, NRCS; Dr. Kris Brye and Lawrence Berry, University of AR Crop, Soil and Environmental Science Department; Dr. Mike Daniels, Professor, Extension Water Quality, University of AR Division of Agriculture; and Cory Hallmark and Josh Hesselbein, University of AR Extension, University of AR Extension.

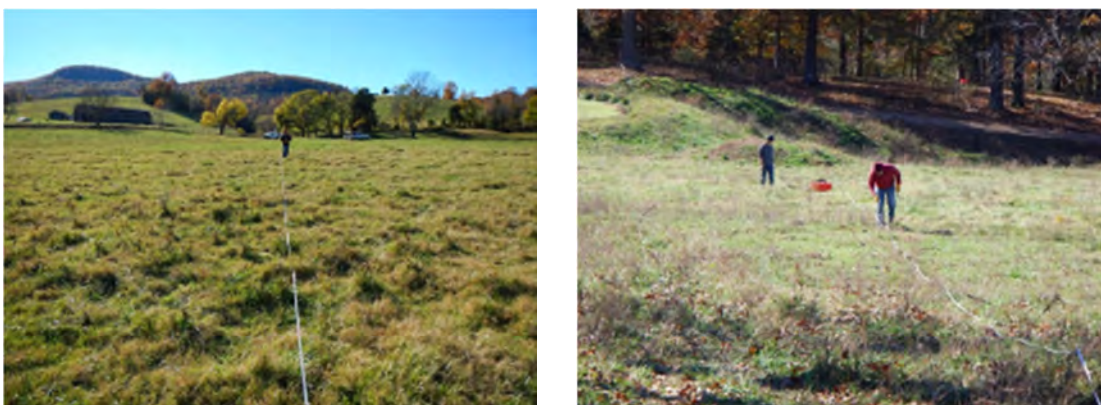
**Figure 1. Preparing a transect for the Ground Penetrating Radar assessment at C&H Farm.**

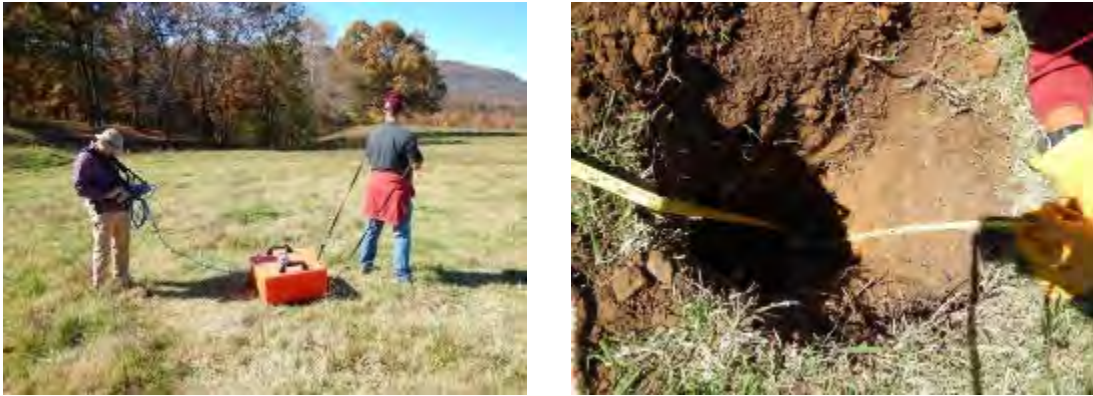
Figure 2. Conducting the Ground Penetrating Radar assessment at C&H Farm.

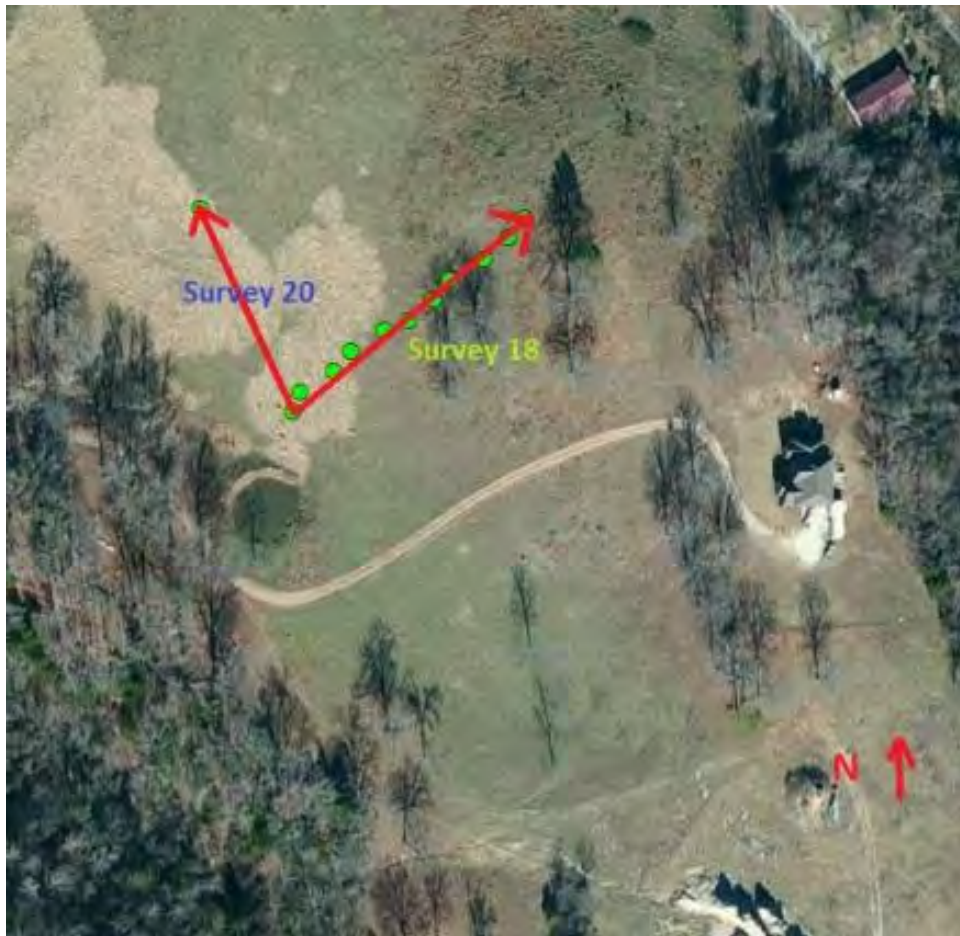
Figure 3. Location of ground penetrating radar surveys at field 1 near Mount Judea, AR. Surveys were 90-m in length.

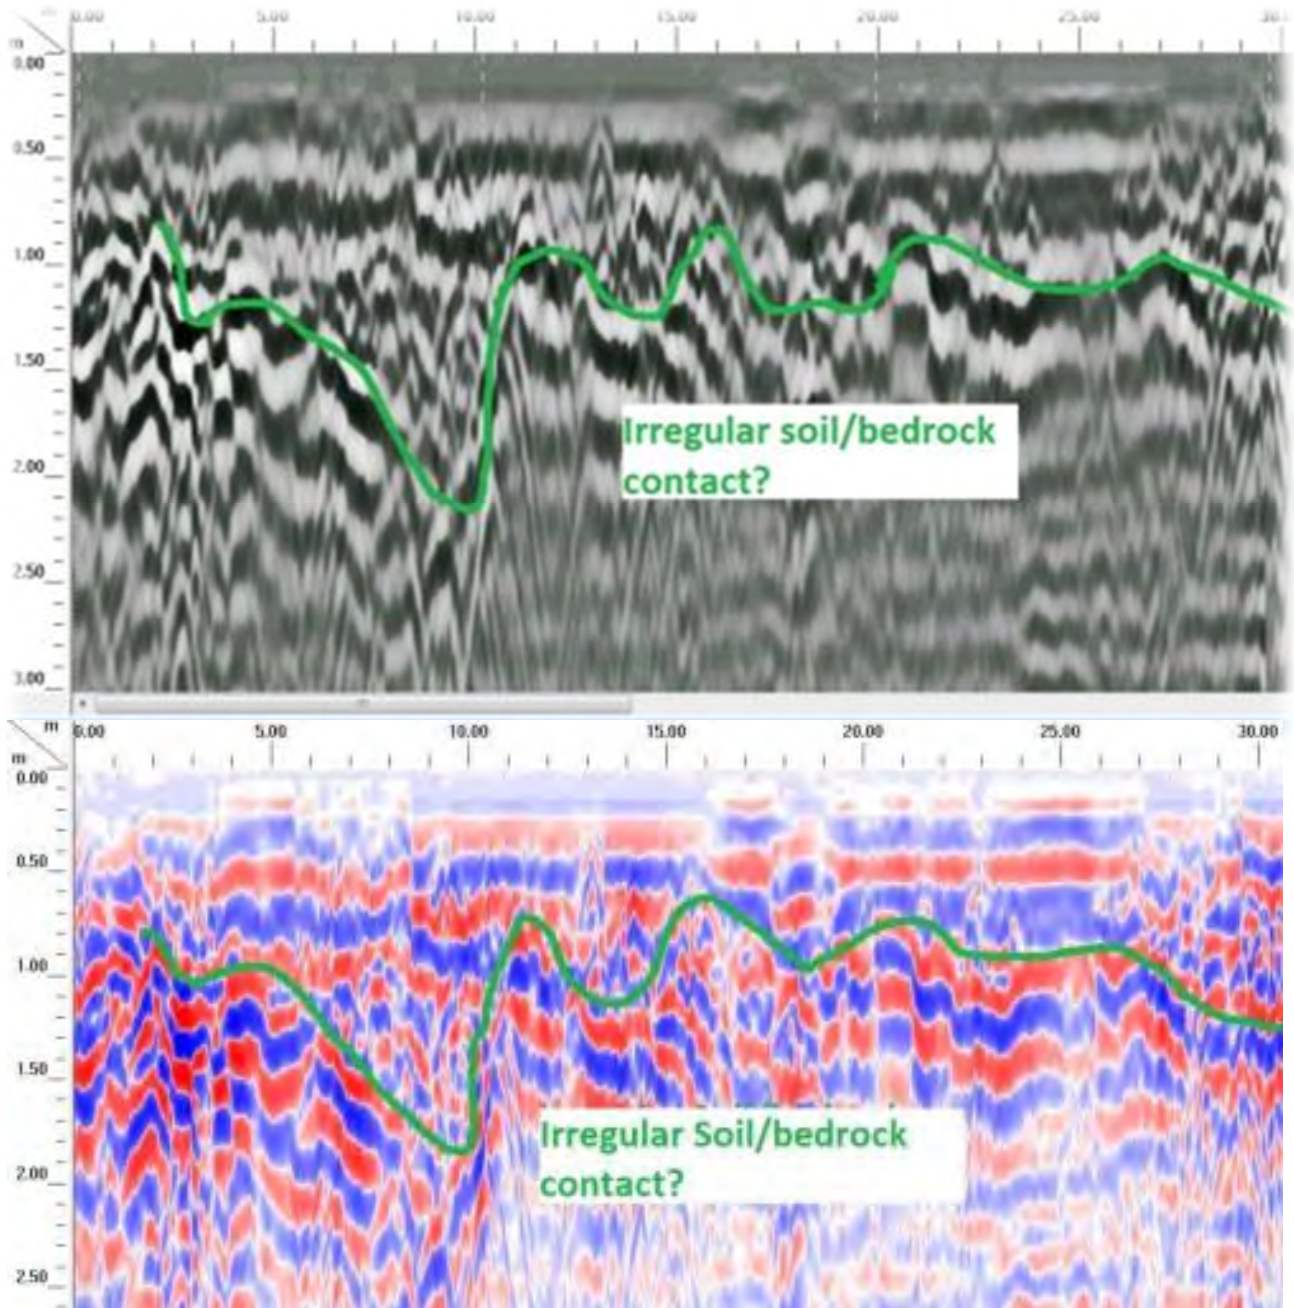
5. The data suggests that there could be an irregularly shaped boundary between soil and bedrock across the survey (Figures 4 and 5). This apparent contact is wavy in nature, and resembles the dissolution features that are manifested in cutter and pinnacle karst.

Figure 5. Two different representations of possible soil/bedrock interface at the beginning of survey 18.

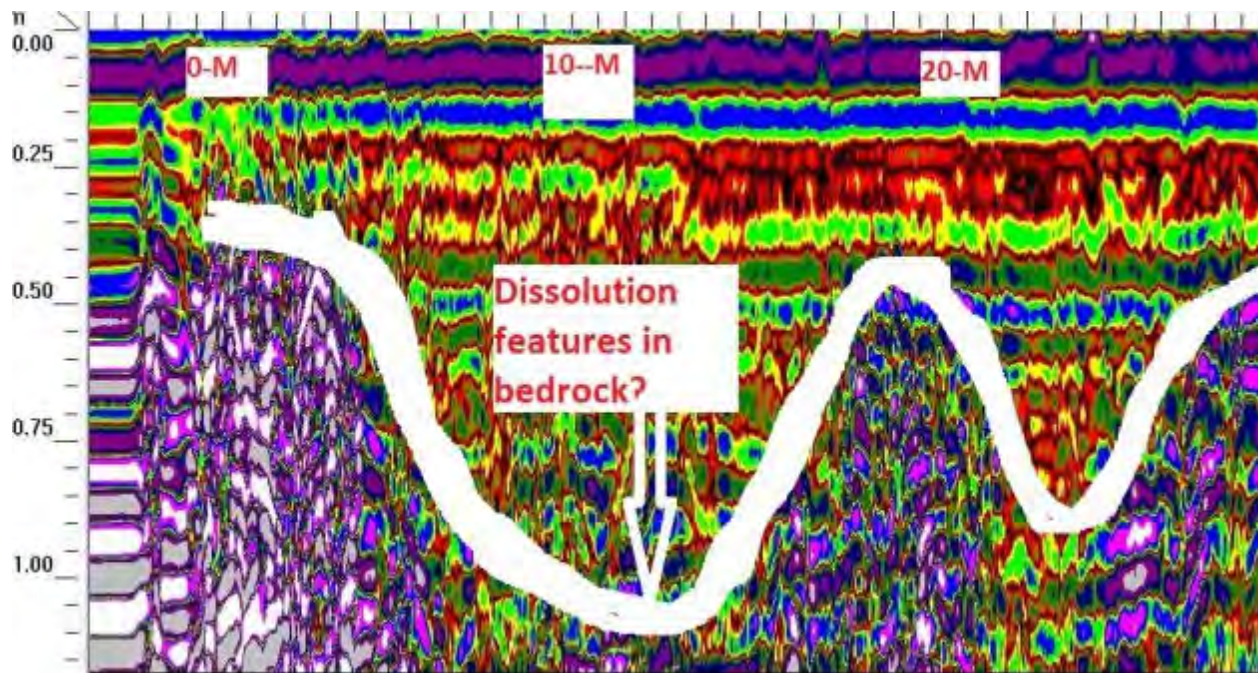
2. The beginning portion of the transect occurred on a toe-slope. The radar record suggests that the soil-bedrock interface could be wavy in nature, which may suggest cutter and pinnacle karst (Figure 8).

**Figure 9.** The first portion of transects 27-28 began on a toe-slope. The transect then dropped down onto a terrace. The toe-slope portion (above) may be underlain by dissolution features.

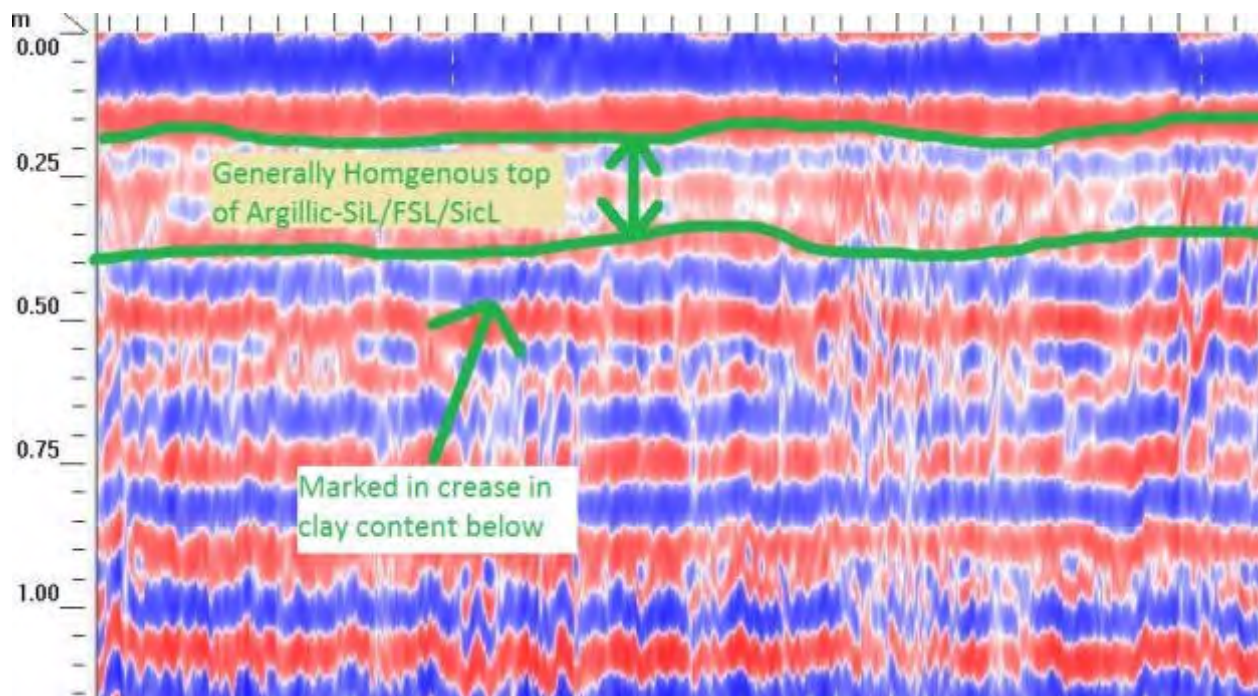
3. The radar record shows a contrasting layer at a depth of around 50 to 60-cm over much of the transect. Field observations found that clay content increased near this depth consistently, changing from silt loam or fine sandy loam to clay, clay loam, or silty clay loam at greater depths (Figure 11).

Figure 11. Typical portion of the radar record from survey 29, along the terrace/flood plain NRCS report and brief interpretation.

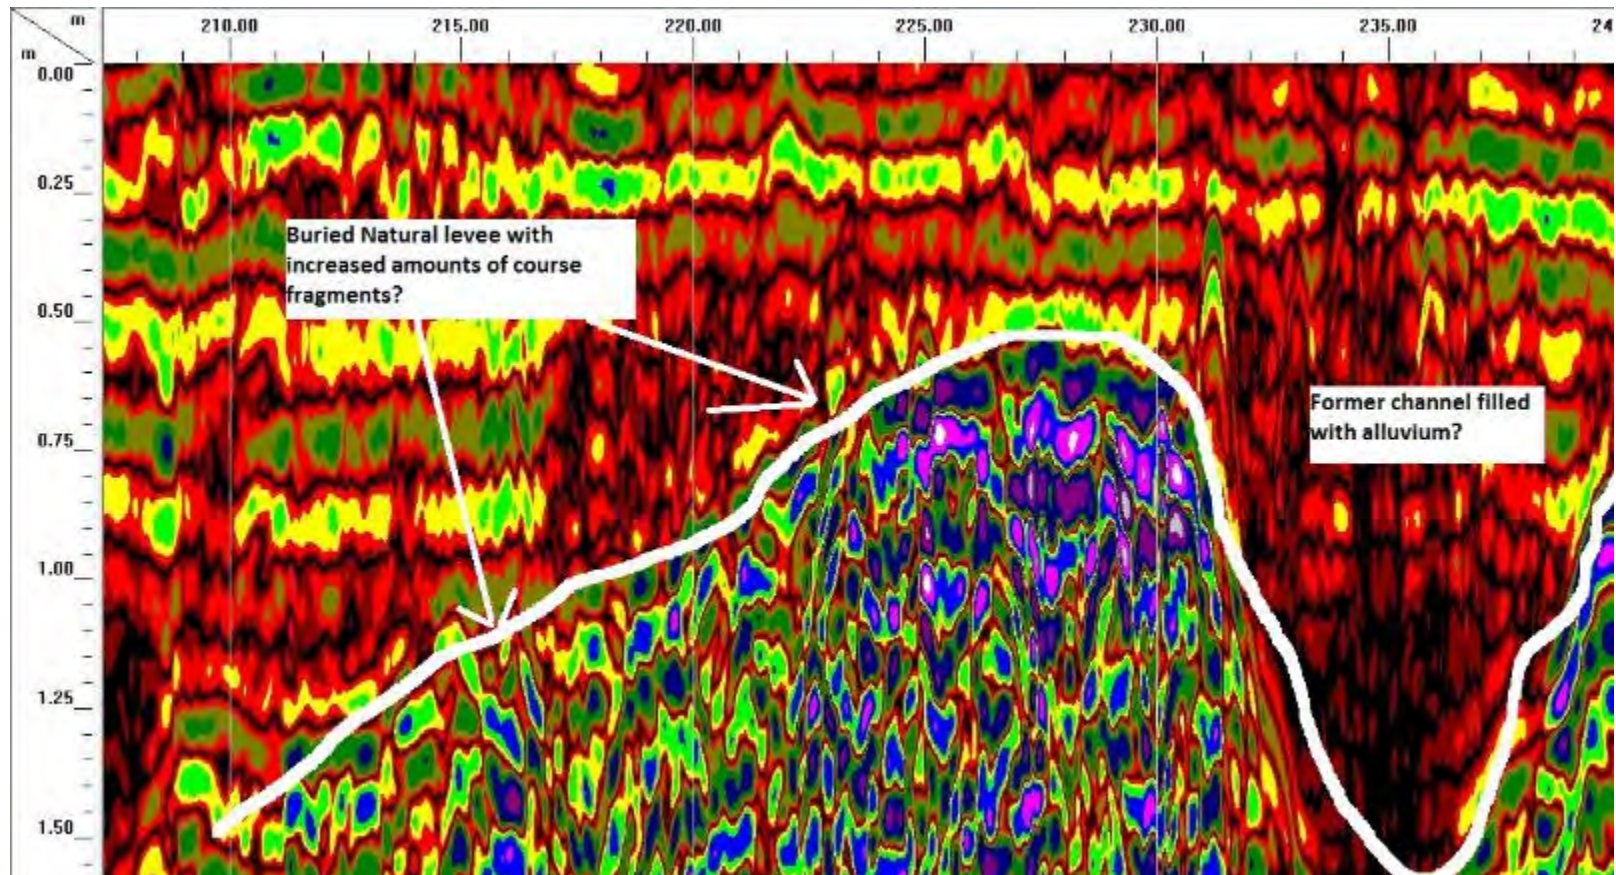
10. An anomaly at the 170-m mark, at around 1-m deep, could be a pocket of coarse fragments deposited by Big Creek (Figure 14).
11. An anomaly was noted on the radar record at the end of survey 3 upon data collection (Figure 15). It resembled possible coarse fragment deposits from the previous field visit. A test whole was augered at around the 225-m mark. The upper soil horizons (0-55-cm) were more sandy in nature than observations further from the creek along this transect. Subsurface textures were sandy loam. At 55-cm, augering was not possible due to coarse fragment content. Coarse fragment content was estimated at 35-45%.

Figure 15. This anomaly at the end of Survey 3 may be a gravel bar deposited by Big Creek.
